SIRE 2.0 Report

Report LTFZ-7070-0594-7277

Vessel Name CALLUNA GAS

Report Type Full

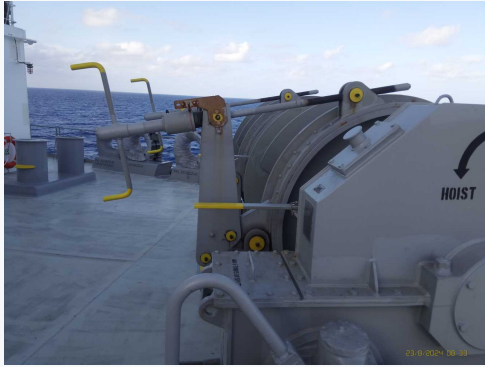
9.1.1. Were the Master and deck officers familiar with the company procedures for the testing and correct operation of the mooring winch brakes, and were records available to demonstrate that brakes had been tested periodically, after maintenance or when there was evidence of premature brake slippage?

Hardware Free from obvious deterioration or deficiency.

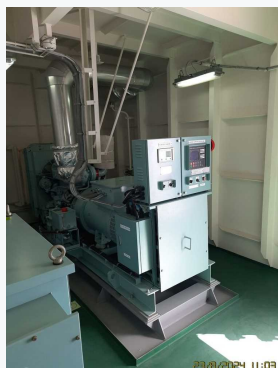
10.2.1. Were the officers familiar with the starting procedure for the emergency generator and were records available to demonstrate that the emergency generator had been tested according to company procedures?

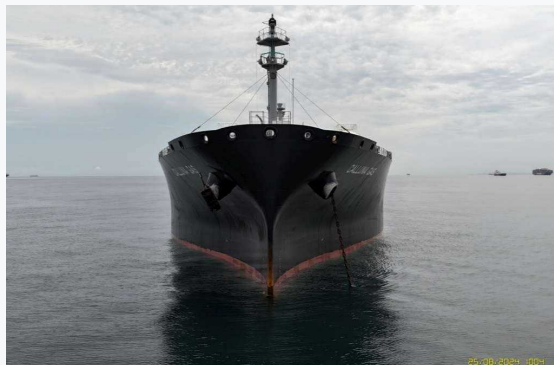
11.1.1. Was photograph no.1, bow area from dead ahead, representative of the condition as seen onboard at the time of the inspection and, if so, was it free of any areas for concern?

Photograph **Photo provided representative.**

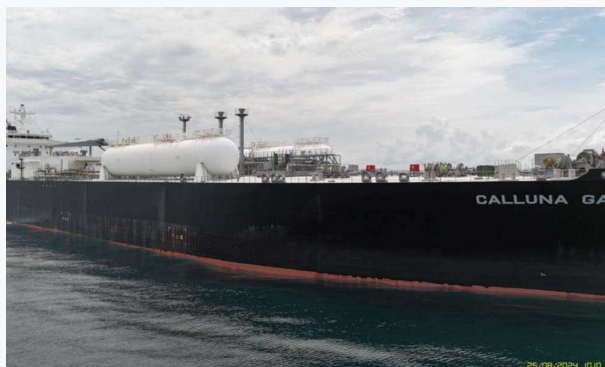
11.1.2. Was photograph no.2, hull forward end starboard side, representative of the condition as seen onboard at the time of the inspection and, if so, was it free of any areas for concern?

Photograph **Photo provided representative.**

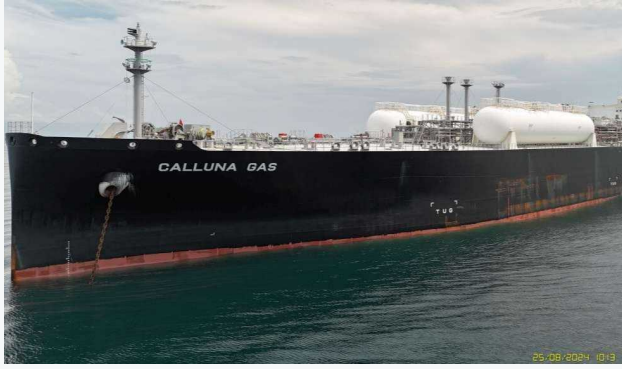
11.1.3. Was photograph no.3, hull forward end port side representative, of the condition as seen onboard at the time of the inspection and, if so, was it free of any areas for concern?

Photograph Photo provided representative.

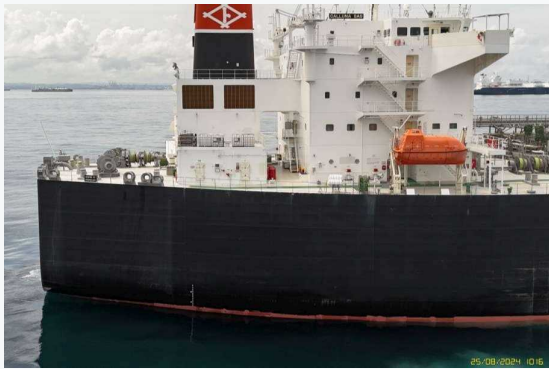
11.1.4. Was photograph no.4, hull aft end starboard side, representative of the condition as seen onboard at the time of the inspection and, if so, was it free of any areas for concern?

Photograph Photo provided representative.

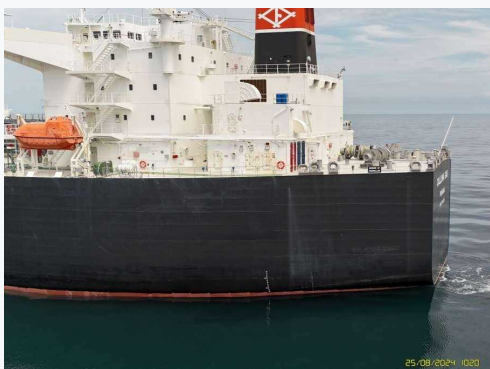
11.1.5. Was photograph no.5, hull aft end port side, representative of the condition as seen onboard at the time of the inspection and, if so, was it free of any areas for concern?

Photograph Photo provided representative.

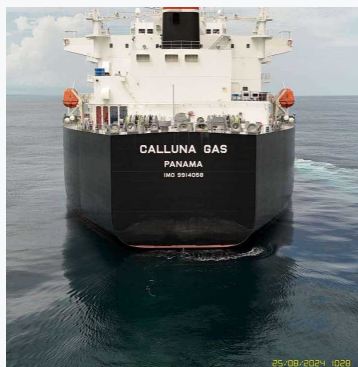
11.1.6. Was photograph no.6, transom from right astern, representative of the condition as seen onboard at the time of the inspection and, if so, was it free of any areas for concern?

Photograph Photo provided representative.

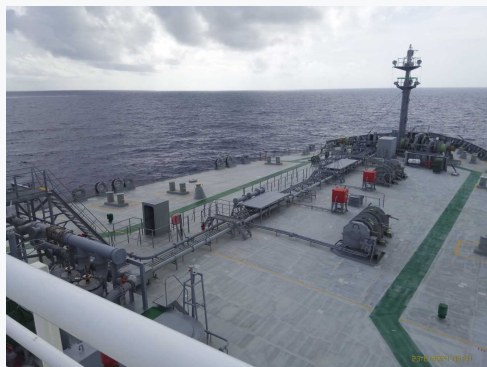
11.1.7. Was photograph no.7, forecastle port side looking towards fairleads, representative of the condition as seen onboard at the time of the inspection and, if so, was it free of any areas for concern?

Photograph Photo provided representative.

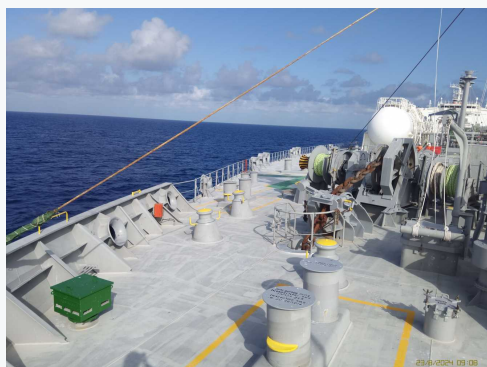
11.1.8. Was photograph no.8, forecastle starboard side looking towards fairleads, representative of the condition as seen onboard at the time of the inspection and, if so, was it free of any areas for concern?

Photograph Photo provided representative.

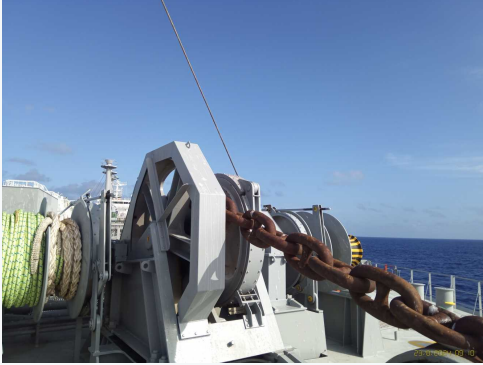
11.1.9. Was photograph no.9, port or starboard windlass, representative of the condition as seen onboard at the time of the inspection and, if so, was it free of any areas for concern?

Photograph Photo provided representative.

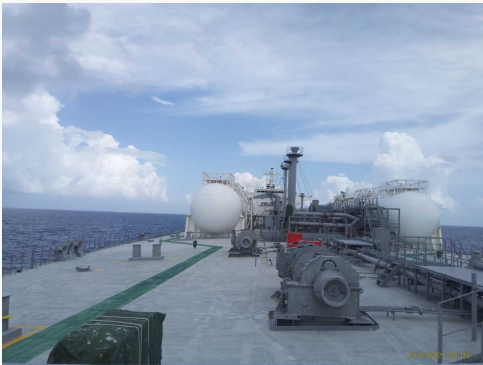
11.1.10. Was photograph no.10, forward main deck showing condition of deck (and external framing), representative of the condition as seen onboard at the time of the inspection and, if so, was it free of any areas for concern?

Photograph Photo provided representative.

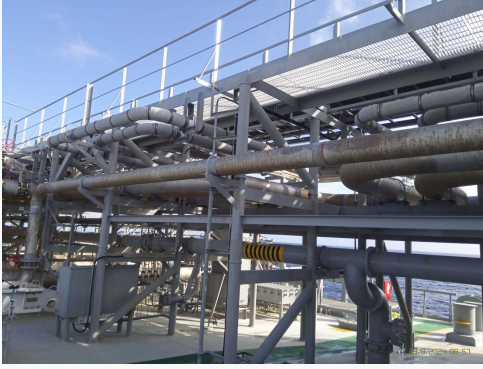
11.1.11. Was photograph no.11, Forward main deck showing condition of piperack, representative of the condition as seen onboard at the time of the inspection and, if so, was it free of any areas for concern?

Photograph Photo provided representative.

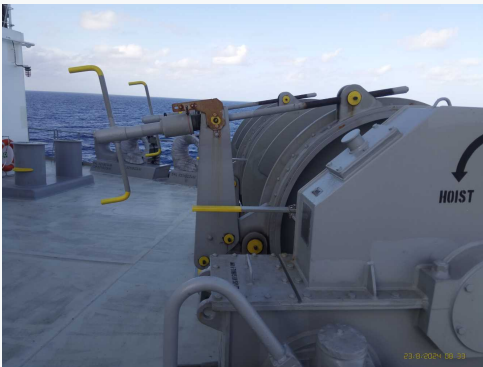
11.1.12. Was photograph no.12, one mooring winch including the brake setting arrangement, representative of the condition as seen onboard at the time of the inspection and, if so, was it free of any areas for concern?

Photograph Photo provided representative.

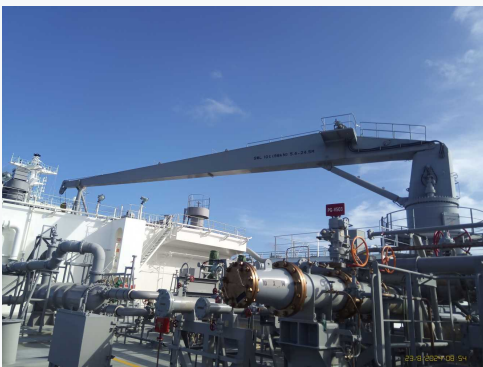
11.1.13. Was photograph no.13, one hose crane with an overall view, representative of the condition as seen onboard at the time of the inspection and, if so, was it free of any areas for concern?

Photograph Photo provided representative.

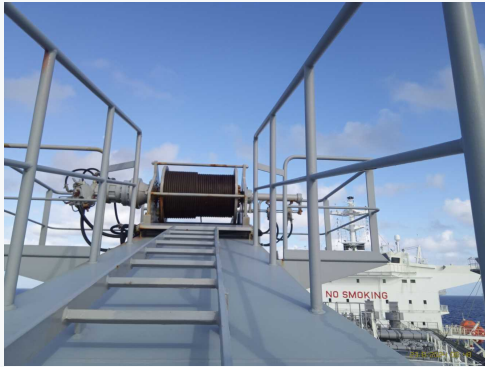
11.1.14. Was photograph no.14, one hose crane hoisting winch, stowed wire and limit switches, representative of the condition as seen onboard at the time of the inspection and, if so, was it free of any areas for concern?

Photograph Photo provided representative.

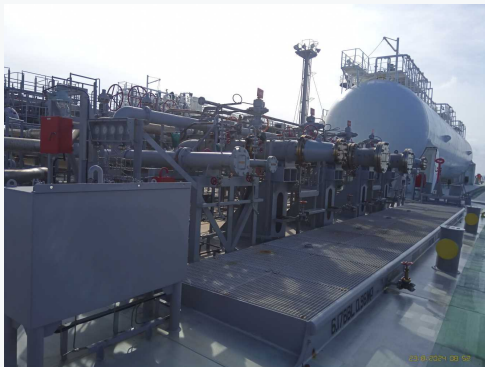
11.1.15. Was photograph no.15, starboard manifold looking from aft to forward, representative of the condition as seen onboard at the time of the inspection and, if so, was it free of any areas for concern?

Photograph Photo provided representative.

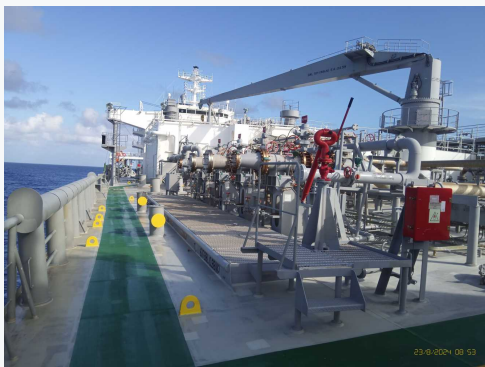
11.1.16. Was photograph no.16, starboard manifold looking forward to aft representative of the condition as seen onboard at the time of the inspection and, if so, was it free of any areas for concern?

Photograph Photo provided representative.

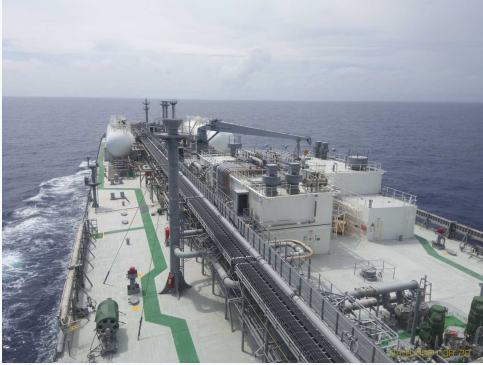
11.1.17. Was photograph no.17, aft main deck showing condition of deck (and external framing), representative of the condition as seen onboard at the time of the inspection and, if so, was it free of any areas for concern?

Photograph Photo provided representative.

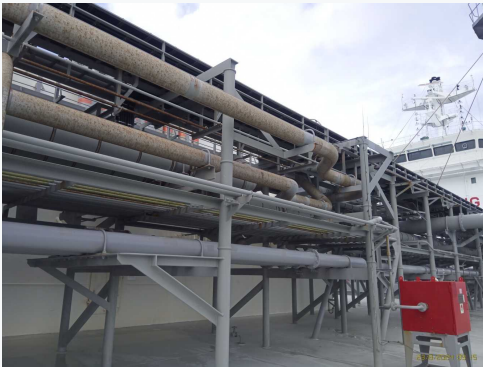
11.1.18. Was photograph no.18, aft main deck showing condition of Piperack, representative of the condition as seen onboard at the time of the inspection and, if so, was it free of any areas for concern?

Photograph Photo provided representative.

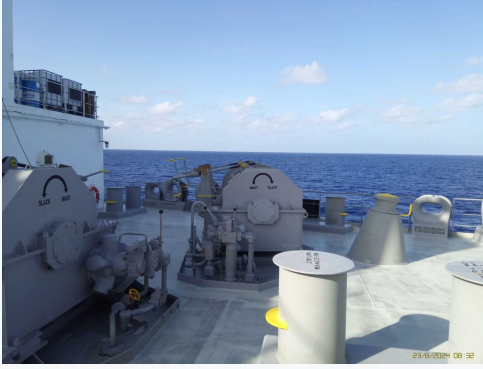
11.1.19. Was photograph no.19, poop deck looking from midships to starboard including fairleads, representative of the condition as seen onboard at the time of the inspection and, if so, was it free of any areas for concern?

Photograph Photo provided representative.

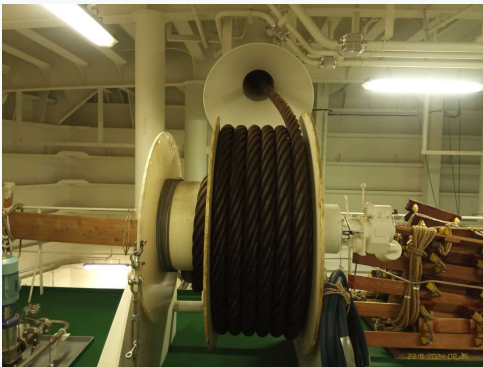
11.1.20. Was photograph no.20, aft emergency towing equipment storage arrangement, representative of the condition as seen onboard at the time of the inspection and, if so, was it free of any areas for concern?

Photograph Photo provided representative.

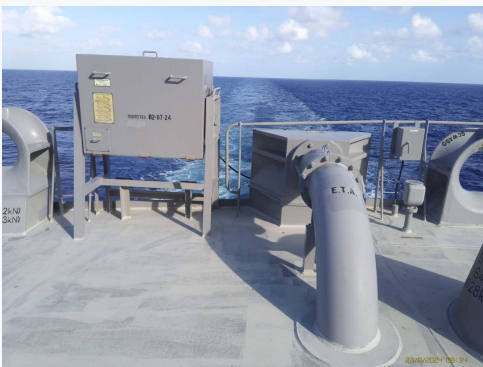
11.1.21. Was photograph no.21, aft emergency towing equipment deployment system, representative of the condition as seen onboard at the time of the inspection and, if so, was it free of any areas for concern?

Photograph Photo provided representative.

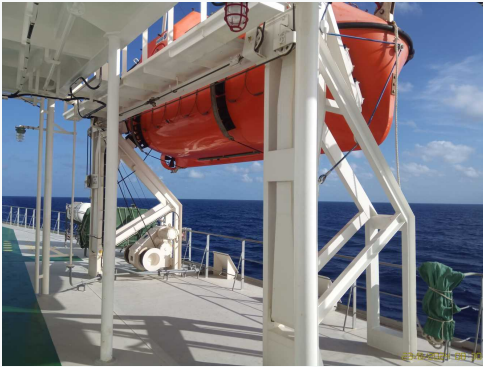
11.1.22. Was photograph no.22, lifeboat and davit, representative of the condition as seen onboard at the time of the inspection and, if so, was it free of any areas for concern?

Photograph Photo provided representative.

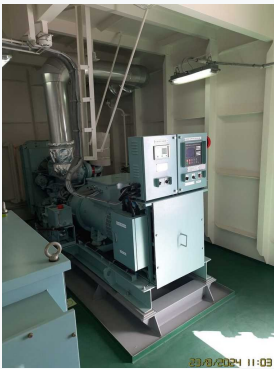
11.1.23. Was photograph no.23, the emergency generator or accumulator batteries, representative of the condition as seen onboard at the time of the inspection and, if so, was it free of any areas for concern?

Photograph Photo provided representative.

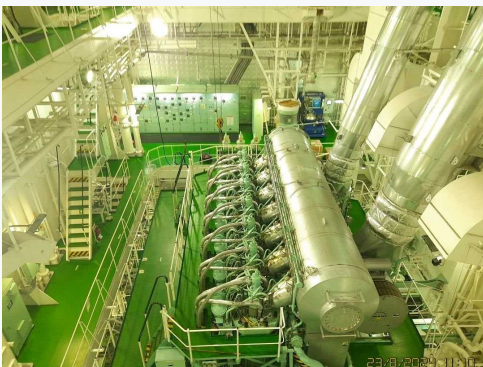
11.1.24. Was photograph no.24, engine room general view showing top of main engine, representative of the condition as seen onboard at the time of the inspection and, if so, was it free of any areas for concern?

Photograph Photo provided representative.

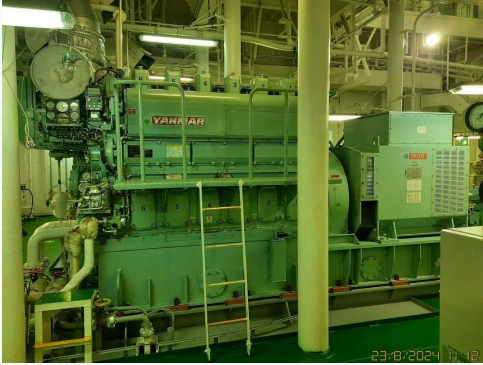
11.1.25. Was photograph no.25, one generator engine, representative of the condition as seen onboard at the time of the inspection and, if so, was it free of any areas for concern?

Photograph Photo provided representative.

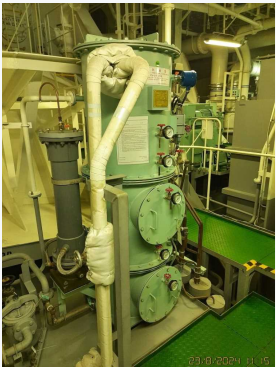
11.1.26. Was photograph no.26, the oil filtering equipment, representative of the condition as seen onboard at the time of the inspection and, if so, was it free of any areas for concern?

Photograph Photo provided representative.

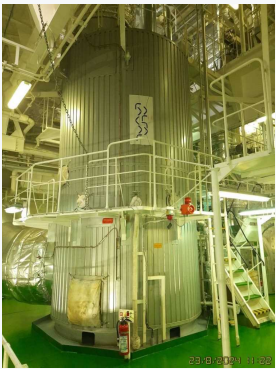
11.1.28. Was photograph no.28, one boiler from the front, representative of the condition as seen onboard at the time of the inspection and, if so, was it free of any areas for concern?

Photograph Photo provided representative.

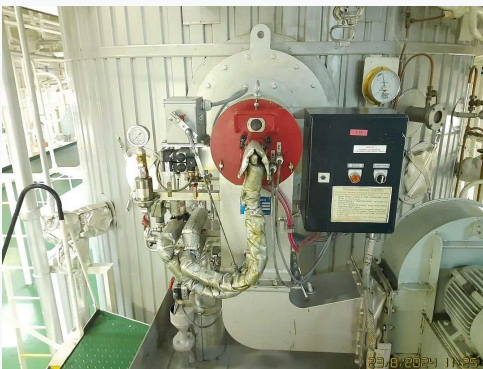
11.1.29. Was photograph no.29, one boiler from the top showing control equipment, representative of the condition as seen onboard at the time of the inspection and, if so, was it free of any areas for concern?

Photograph Photo provided representative.

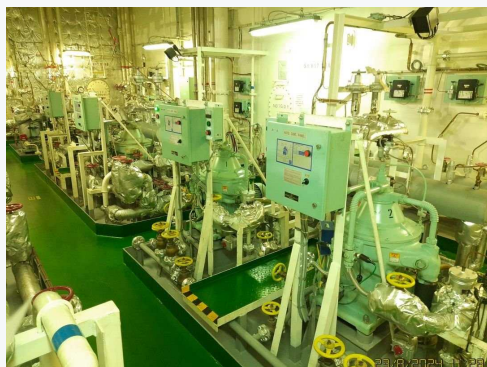
11.1.30. Was photograph no.30, purifier room general view, representative of the condition as seen onboard at the time of the inspection and, if so, was it free of any areas for concern?

Photograph Photo provided representative.

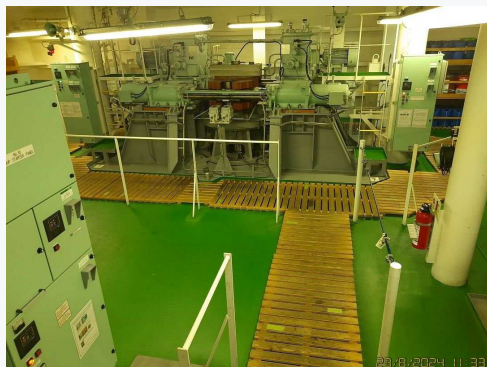
11.1.32. Was photograph no.32, steering gear room general view showing access, representative of the condition as seen onboard at the time of the inspection and, if so, was it free of any areas for concern?

Photograph Photo provided representative.

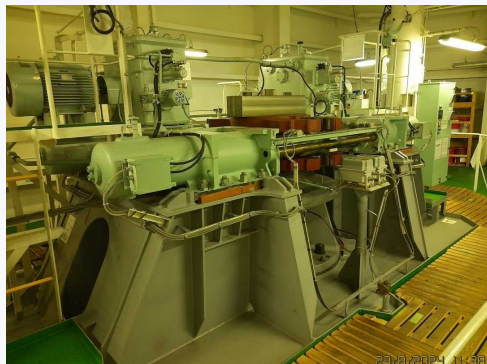
11.1.33. Was photograph no.33, main steering gear, representative of the condition as seen onboard at the time of the inspection and, if so, was it free of any areas for concern?

Photograph Photo provided representative.

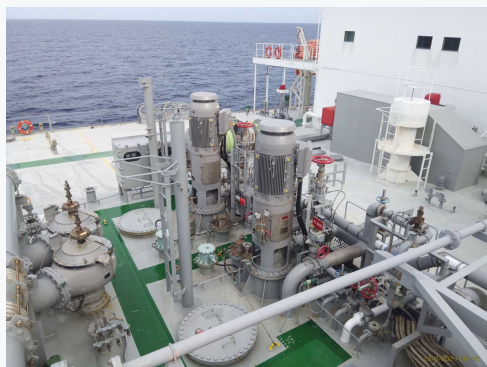
11.1.60. Was photograph no.60, a cargo tank liquid dome including load and discharge valve, representative of the condition as seen onboard at the time of the inspection and, if so, was it free of any areas for concern?

Photograph Photo provided representative.

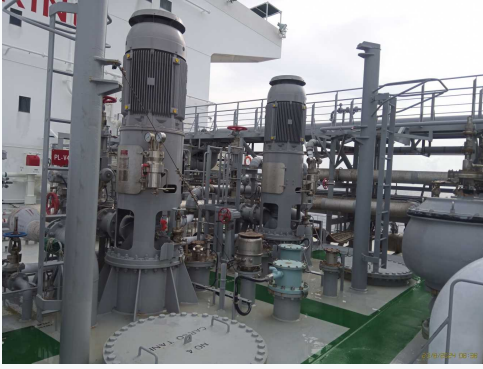
11.1.61. Was photograph no.61, electric motors for deepwell pumps, representative of the condition as seen onboard at the time of the inspection and, if so, was it free of any areas for concern?

Photograph Photo provided representative.

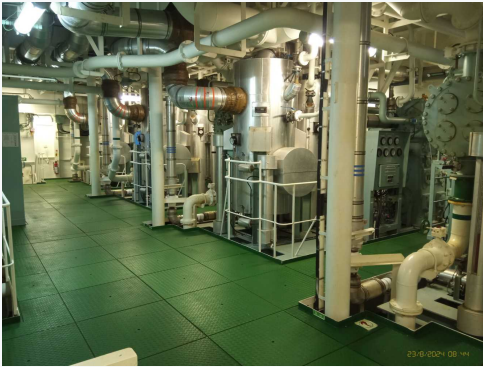
11.1.62. Was photograph no.62, compressor room internal view, representative of the condition as seen onboard at the time of the inspection and, if so, was it free of any areas for concern?

Photograph Photo provided representative.
